MEMORANDUM

TO: Marcelo Chialastri
FROM: Javier Rodriguez, JRV & Associates
DATE: April 22nd, 2017
RE: 730 Coral Way Condominium – Basement Garage Water Intrusion

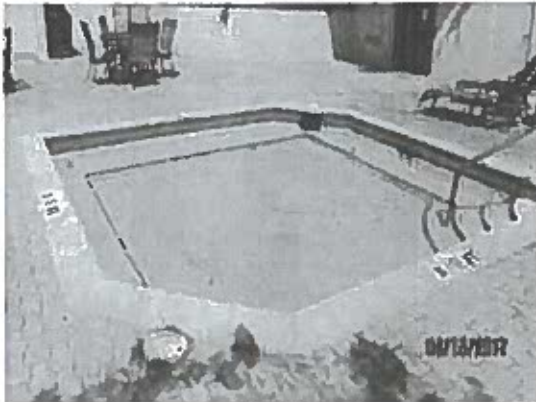
7. Numerous cracks with signs of water intrusion, efflorescence and calcium formation were observed at the underside of the pool deck throughout areas exposed to the elements above.
8. Water marks/stains were observed on top of the basement parking slab, particularly noticeable along construction joints, cracks, area surrounding building columns, at the joint between slab and perimeter basement walls and in the vicinity of the two drains serving the basement parking garage.
9. Exposed and corroded steel reinforcement was observed at the bottom of some concrete columns at the basement parking garage.

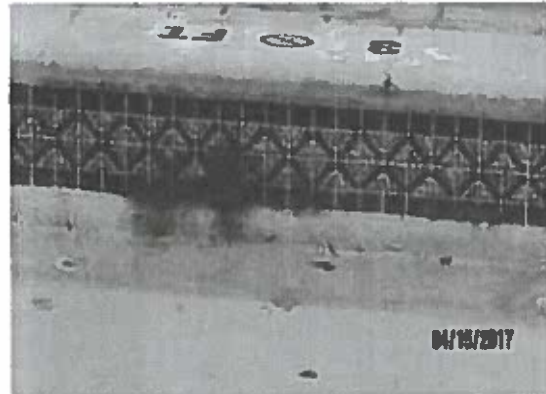
Corrosion at North wall of pool

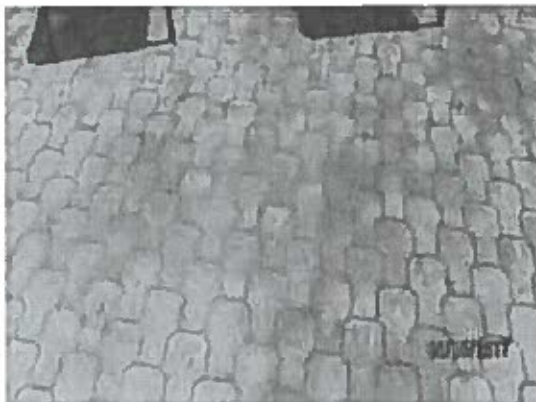
Water/stain marks at pool deck pavers

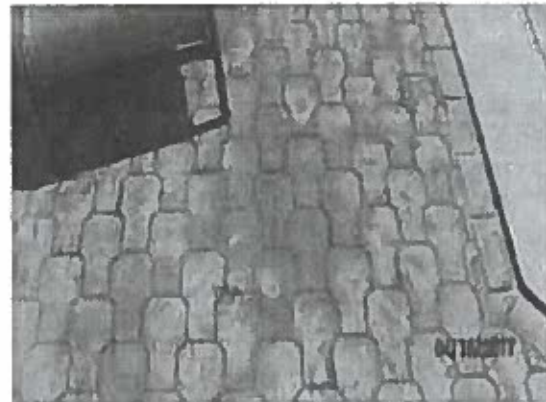
Water/stain marks at pool deck pavers

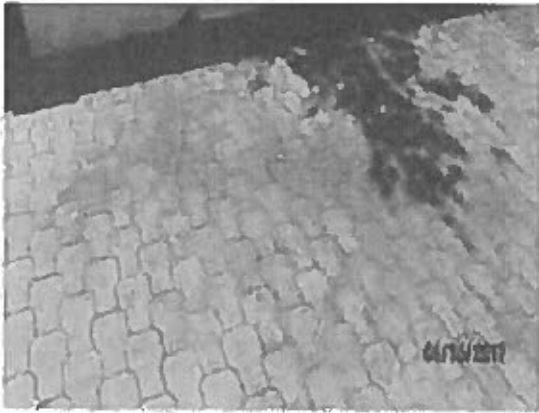
Water/stain marks at pool deck pavers

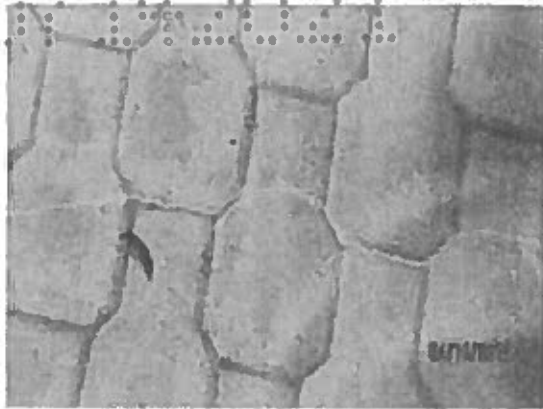
Cracks at concrete pavers

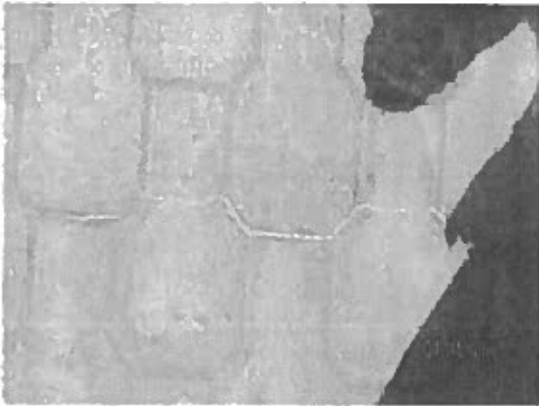
Cracks at concrete pavers

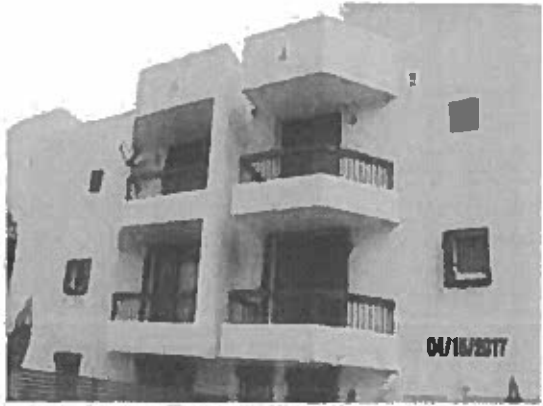
Overflow scuppers without downspout

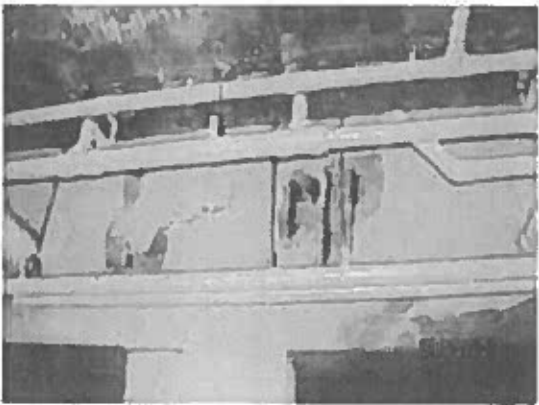
Damaged pool wall at Basement

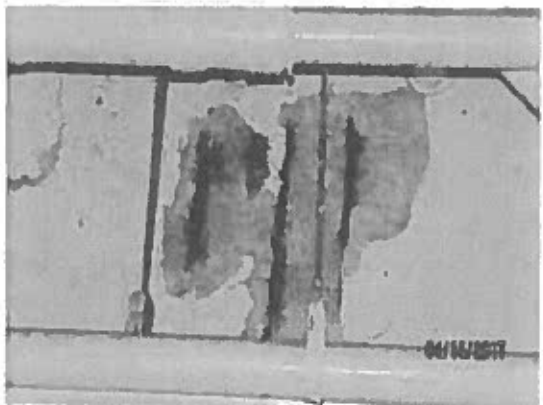
Damaged pool wall at Basement

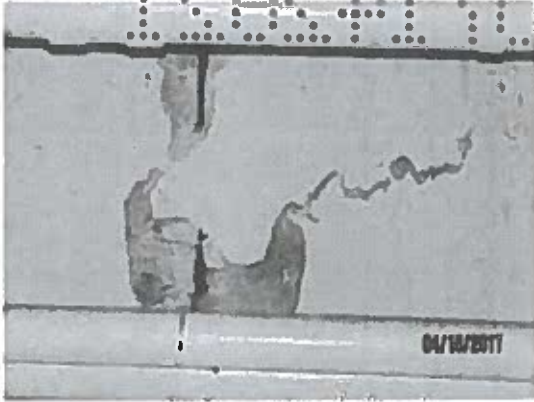
Damaged pool wall at Basement

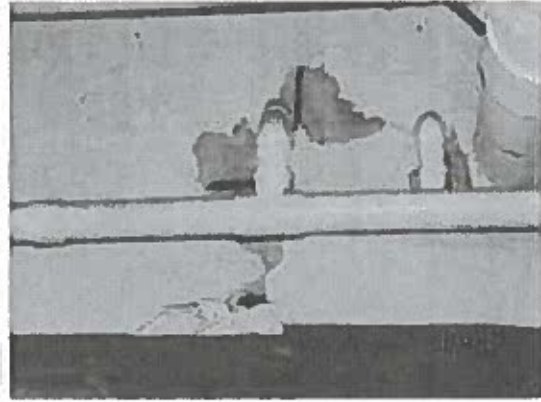
Damaged pool wall at Basement

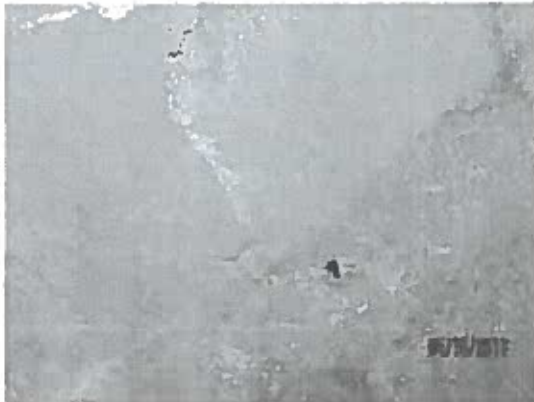
Spalled concrete at underside of pool deck

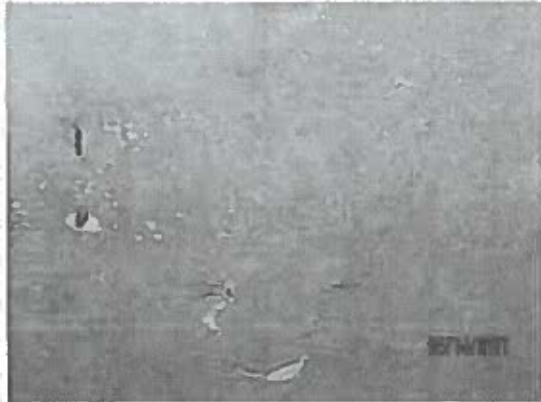
Spalled concrete at underside of pool deck

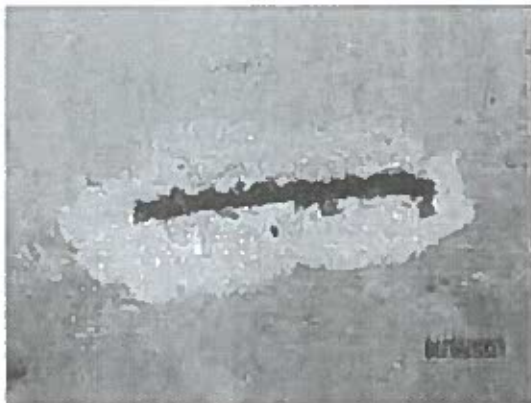
Spalled concrete and exposed steel reinforcement at underside of pool deck

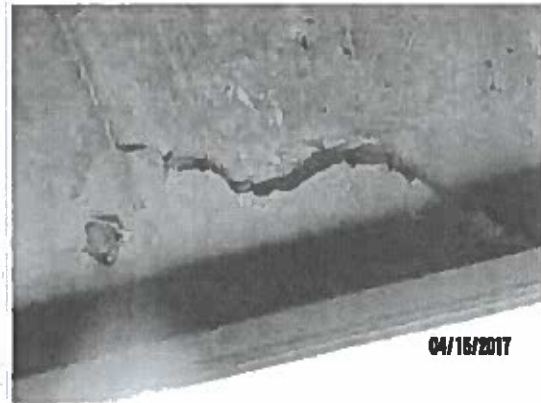
Spalled concrete at underside of pool deck

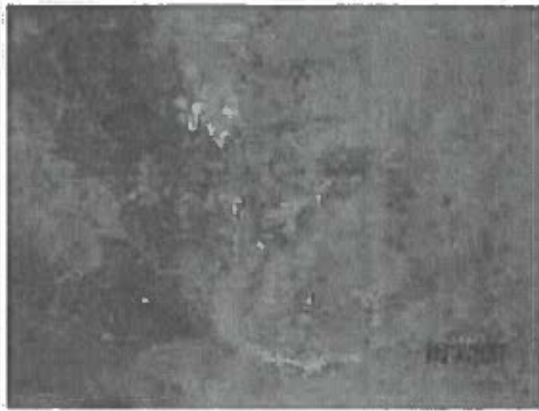
**Cracks with water intrusion signs
at underside of pool deck**

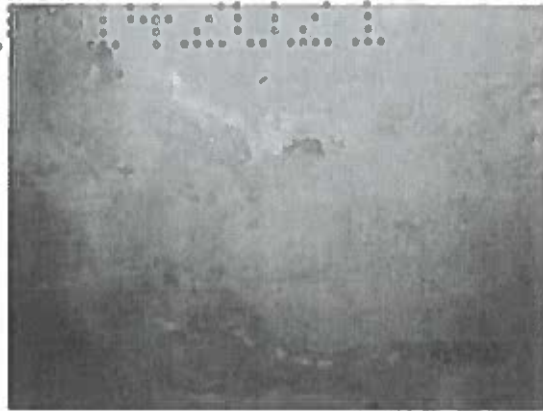
**Cracks with water intrusion signs
at underside of pool deck**

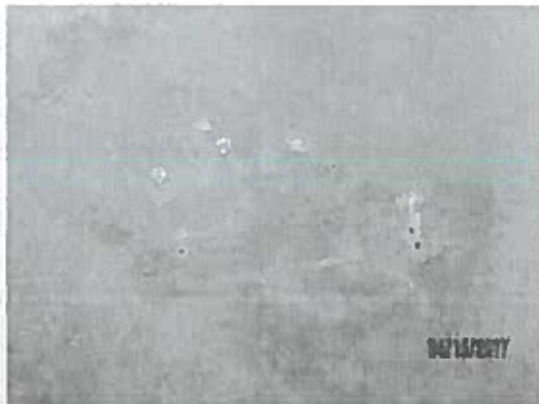
**Cracks with water intrusion signs
at underside of pool deck**

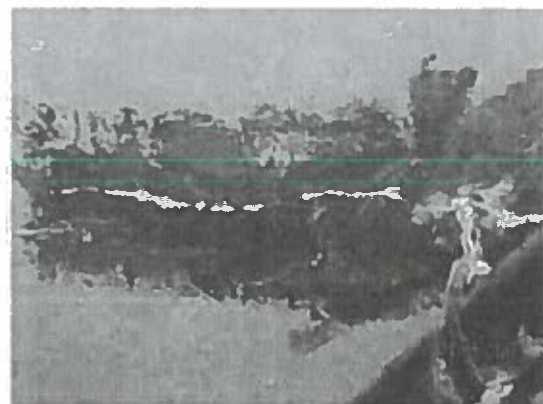
**Cracks with water intrusion signs
at underside of pool deck**

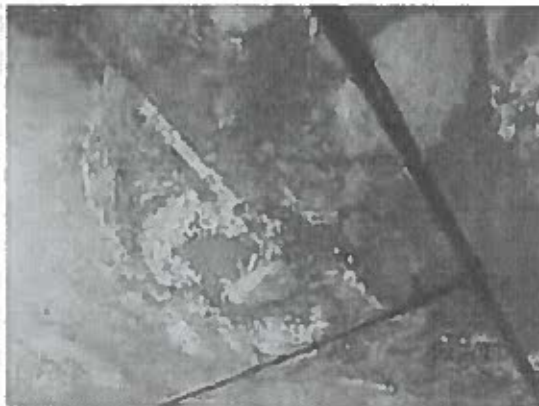
**Water intrusion signs at underside of
pool deck**

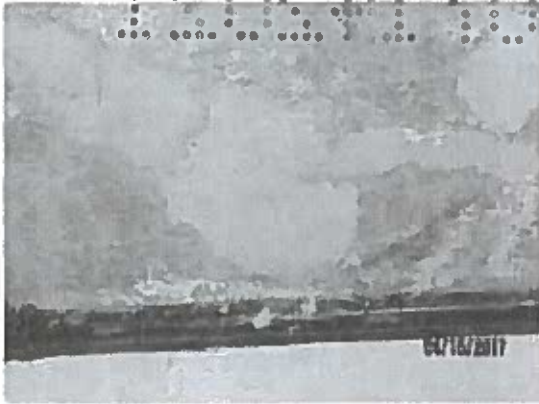
Repairs with water intrusion signs at underside of pool deck

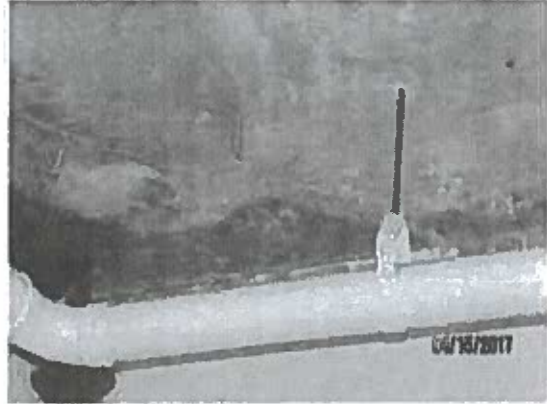
Repairs with water intrusion signs at underside of pool deck

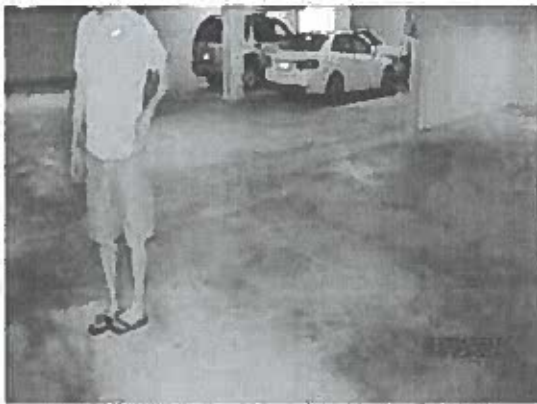
Water marks/stains at basement slab

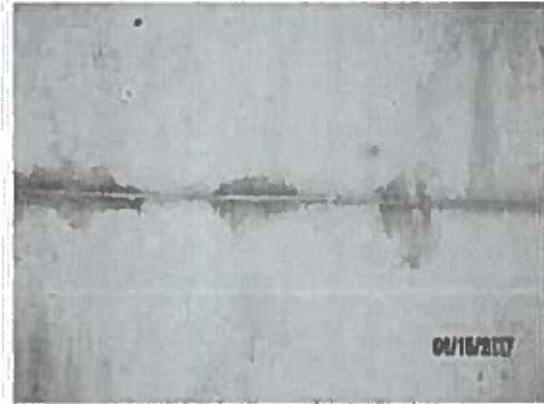
Water marks/stains at basement slab

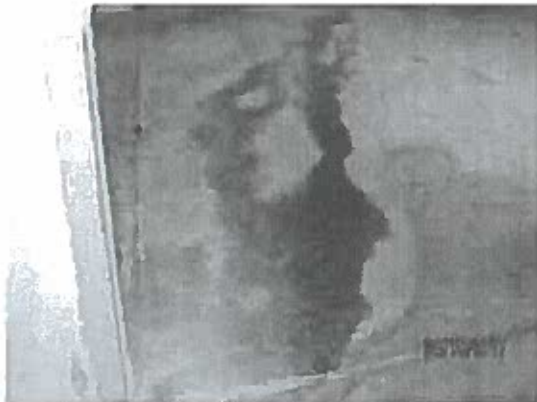
Water marks/stains at basement slab

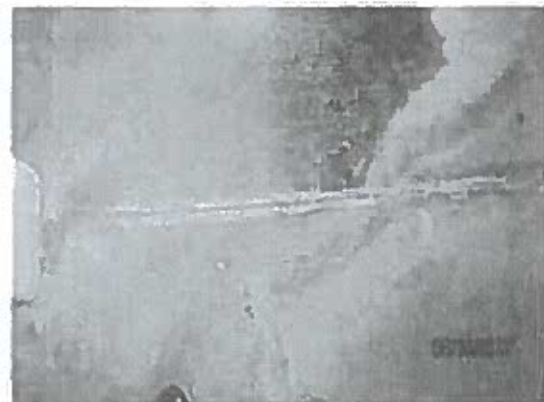
Water marks/stains at basement slab

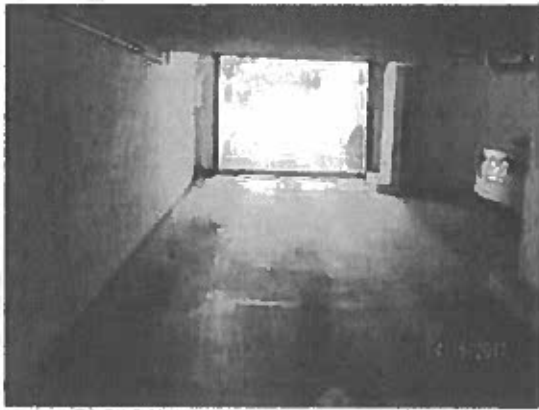
Water marks/stains at basement slab

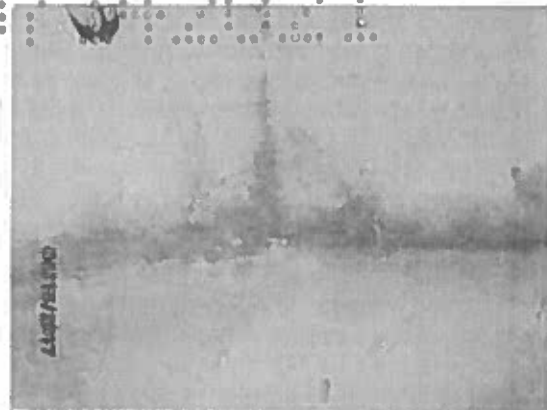
Water marks/stains at basement slab

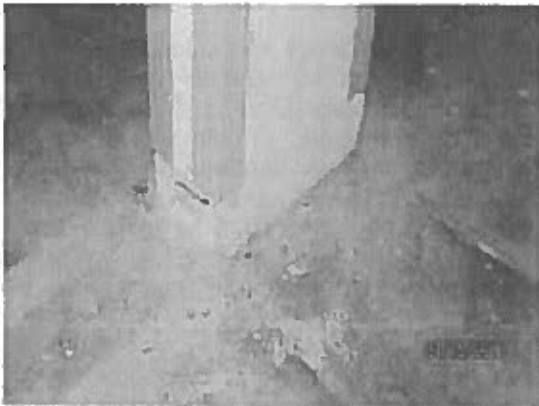
Exposed and corroded column steel reinforcement

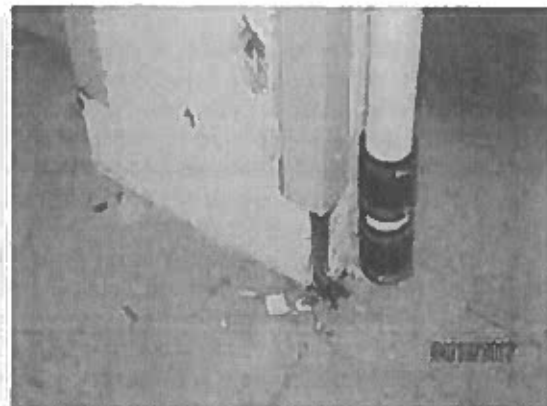
Exposed and corroded column steel reinforcement
